Applies To: **2007–11 CR-V** – Check the iN VIN status for eligibility**May 30, 2014****Warranty Extension: A/C Compressor Clutch**

(Supersedes 12-072, dated July 30, 2013, to revise the information marked by the black bars)

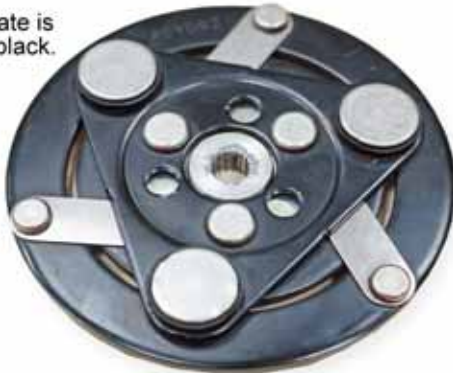
**OK**  
Armature plate is semi-gloss black.

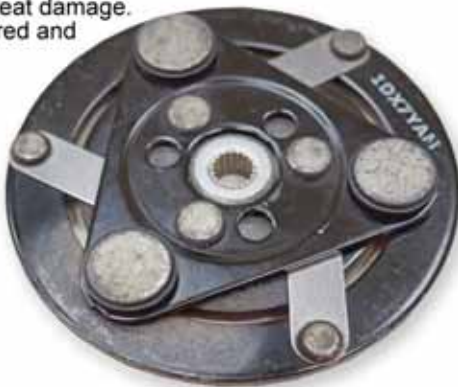
**NO GOOD**  
Moderate heat damage. Paint blistered and flaked off.

Replace the A/C compressor clutch (armature plate and rotor pulley) and, if needed, also replace the field coil.

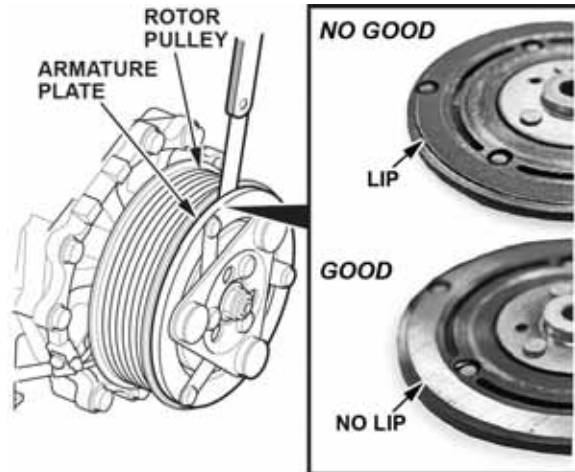
2. Check the clutch clearance between the rotor pulley and the armature plate by trying to insert a 0.027 in. (0.66 mm) feeler gauge in different places all the way around the armature plate. The proper clearance should be between **0.014–0.026 in. (0.35–0.65 mm)**.

- Make sure you measure all the way around the armature plate because the back of the armature may wear unevenly; some areas may be within spec, while others are not.
- If the clearance is close to the maximum, the clutch makes an engagement noise that may be the source of the customer's complaint.

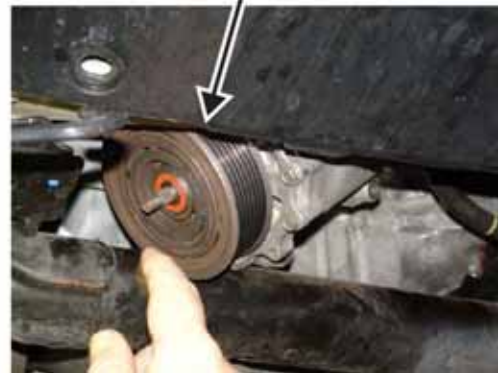
- Using the A/C clutch holder from the A/C Compressor Kit, T/N 07AAF-000A150, remove the center armature plate nut. For more information about removing the A/C compressor clutch, refer to the *Tech2Tech* segment titled "Safely Remove That Rotor Pulley with the A/C Compressor Kit."

- Remove the armature plate and the shim(s). Save the shim(s) to use as a baseline when assembling the new clutch parts.

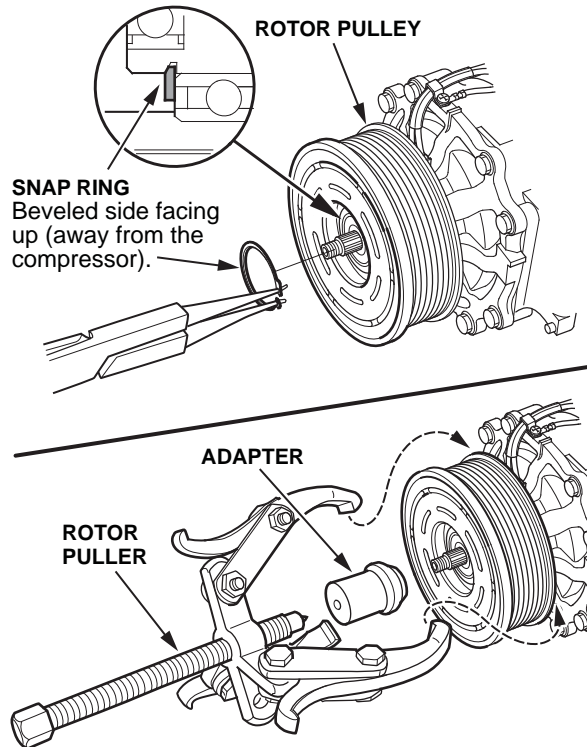
9. Remove the rotor pulley (A/C clutch).
  - Remove the snap ring.
  - Remove the rotor pulley. Always use the rotor puller and large adapter from the A/C compressor kit. Make sure the puller jaws have their narrow ends grabbing the back face of the pulley, not the grooves. Flip the jaws around if necessary. Do not hammer or pry on the rotor pulley because you can damage the A/C compressor. If the pulley does not come off easily, make sure the snap ring was removed.
  - If you are replacing the field coil, go to step 10.
  - If you are not replacing the field coil, go to step 12.

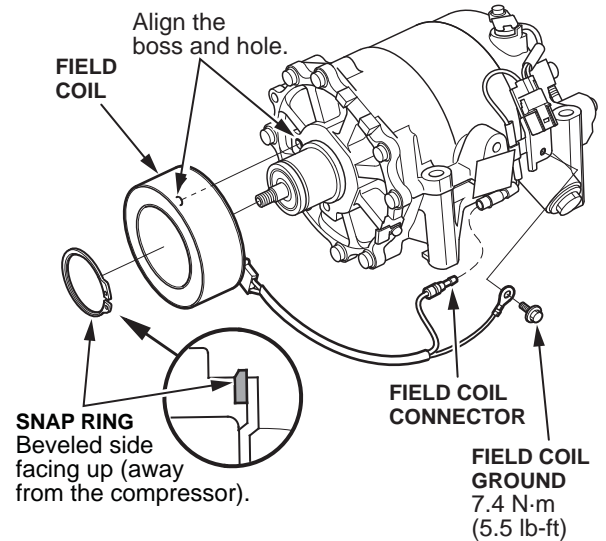
10. Remove the field coil:
  - Remove the field coil ground bolt, then loosen the field coil harness retainer screw. Use a right angle ratcheting screwdriver (Snap-On YA480B or equivalent) to make this easier. Rotate the clip, and unplug the field coil connector.
  - Remove the snap ring, then remove the field coil. Be careful not to damage the field coil and A/C compressor.
